Septum Lifetime with Scion 8400 AutoSampler

Randall Bramston-Cook

Lotus Consulting

August 1, 2018

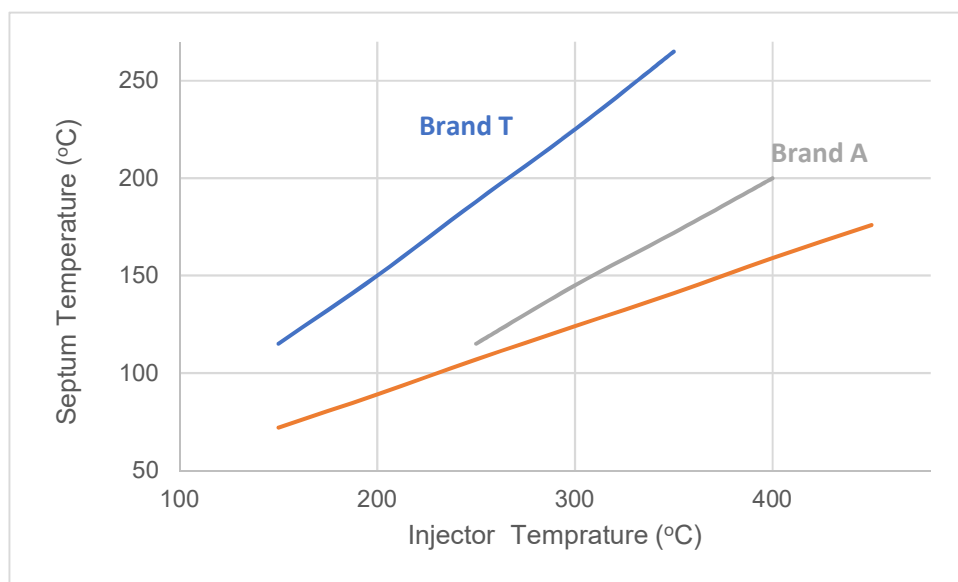
Figure 1. Septum temperatures versus Injector Temperature Settings.

Temperature at the septum location is a major cause for failures. The temperature realized at this location may be below the setpoint for this zone, due to cooling effects of the septum nut injector construction and location of the heater and probe relative to the septum. Figure 1¹ illustrates typical temperatures at the septum location versus injector temperature setpoint.

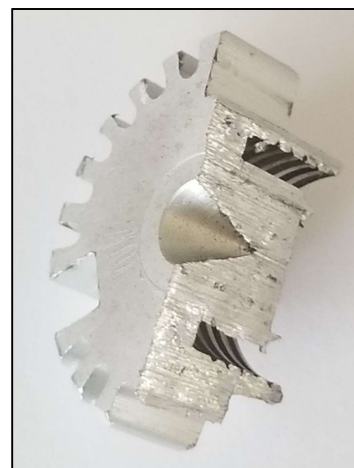
Figure 2. Cross-section view of Scion injector nut.

Septum nuts for Scion GC injectors are tapered down to an exit hole at the bottom of the nut is 0.035" diameter and provides a tight fit for many syringes with a needle outside diameter of 0.018" (gauge 26) (see Figure 2). This taper aids in directing the syringe needle to the center of the septum.

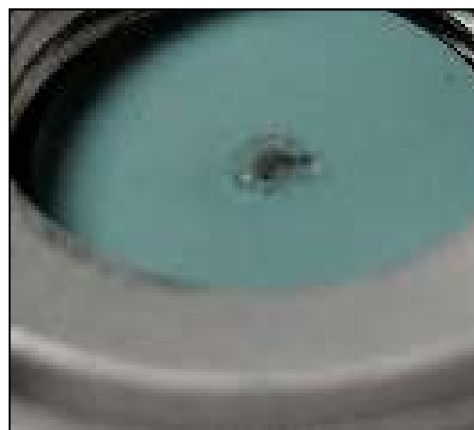
Figure 5. Magnified view of inside of septum after 750 injections. Shape of hole matches perfectly with the contours of the syringe point.

A strong advantage of automated samplers is the ability to make multiple measurements unattended. Also, they are very mechanical and can perform repetitive injections with precision, hitting the same spot on the septum (see Figures 4 and 5). This exactness yields longer life for septa. Performing the same tasks with manual injections will not achieve this extended performance.
